PORTLAND HARBOR PROPOSAL PLAN COMMENTS

SILTRONIC CORPORATION

PREPARED FOR
SILTRONIC CORPORATION
SEPTEMBER 6, 2016
PROJECT NO. 8128.02.03

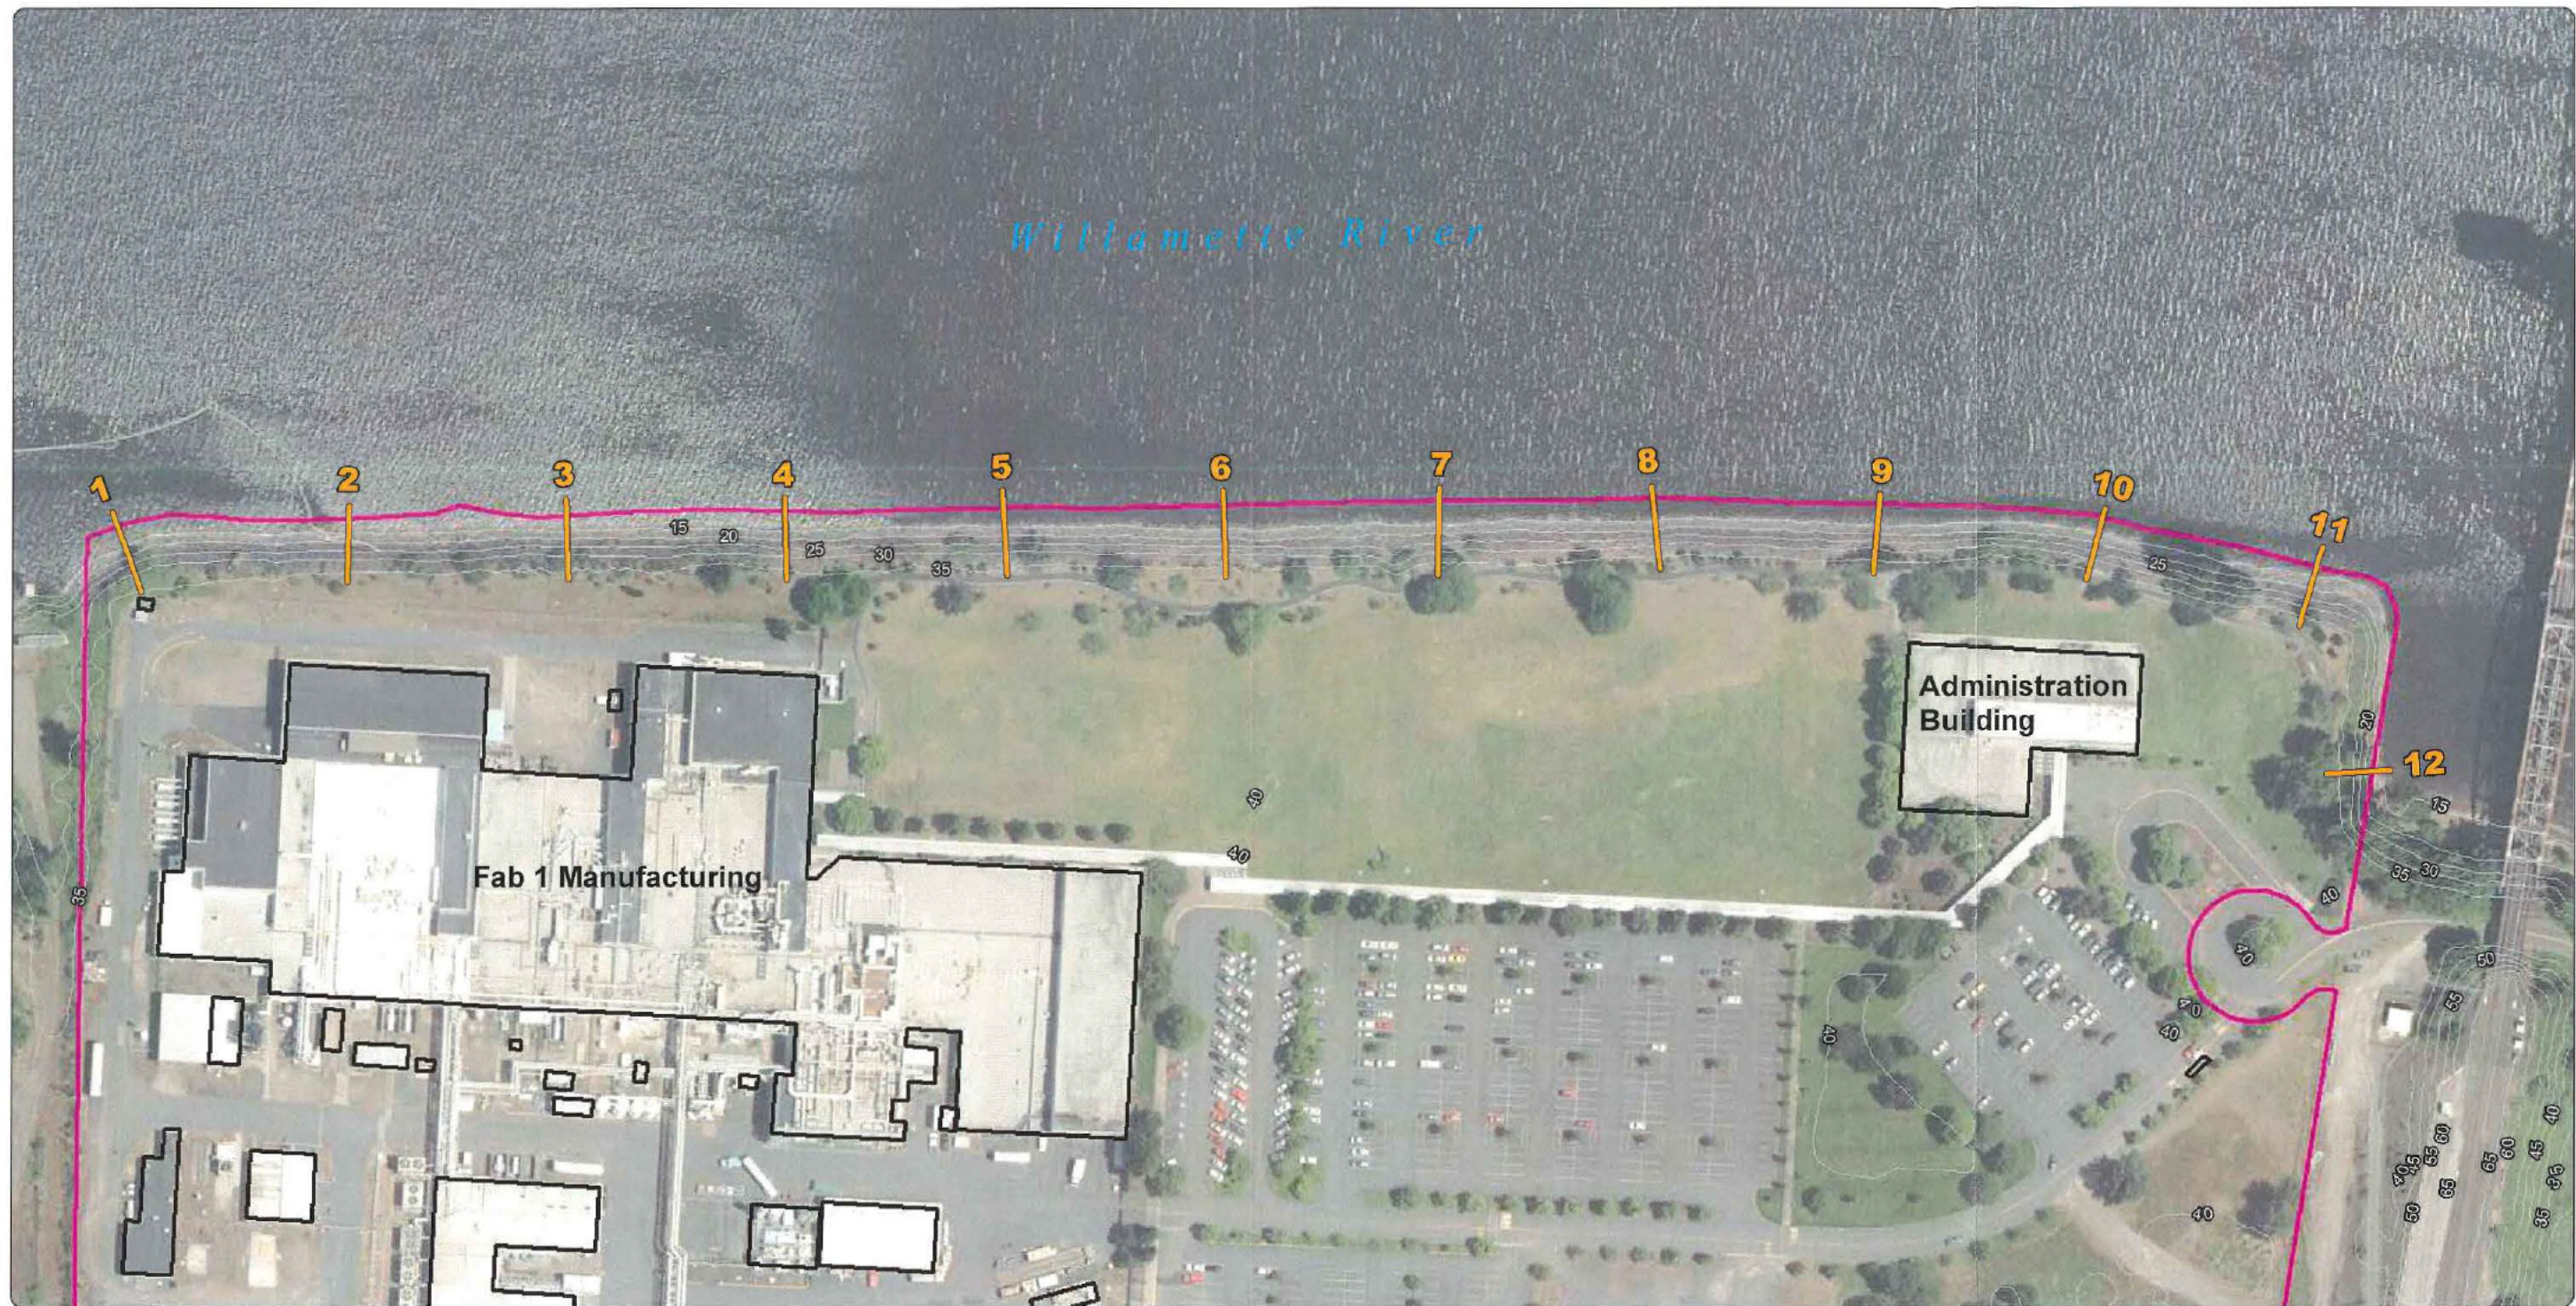
Source: Aerial photograph (2012) obtained from City of Portland; elevations obtained from 2005 Columbia River dataset, Puget Sound LIDAR Consortium.

The BEHI was assessed along 12 transects spaced at 200-foot intervals along the riverbank. Figure 1 shows the location of the 12 transects. The elevation profiles of transects 1 through 4, 5 through 8, and 9 through 12 are presented in Figures 2, 3, and 4, respectively. Representative photographs of the bank conditions are provided in Attachment 1.

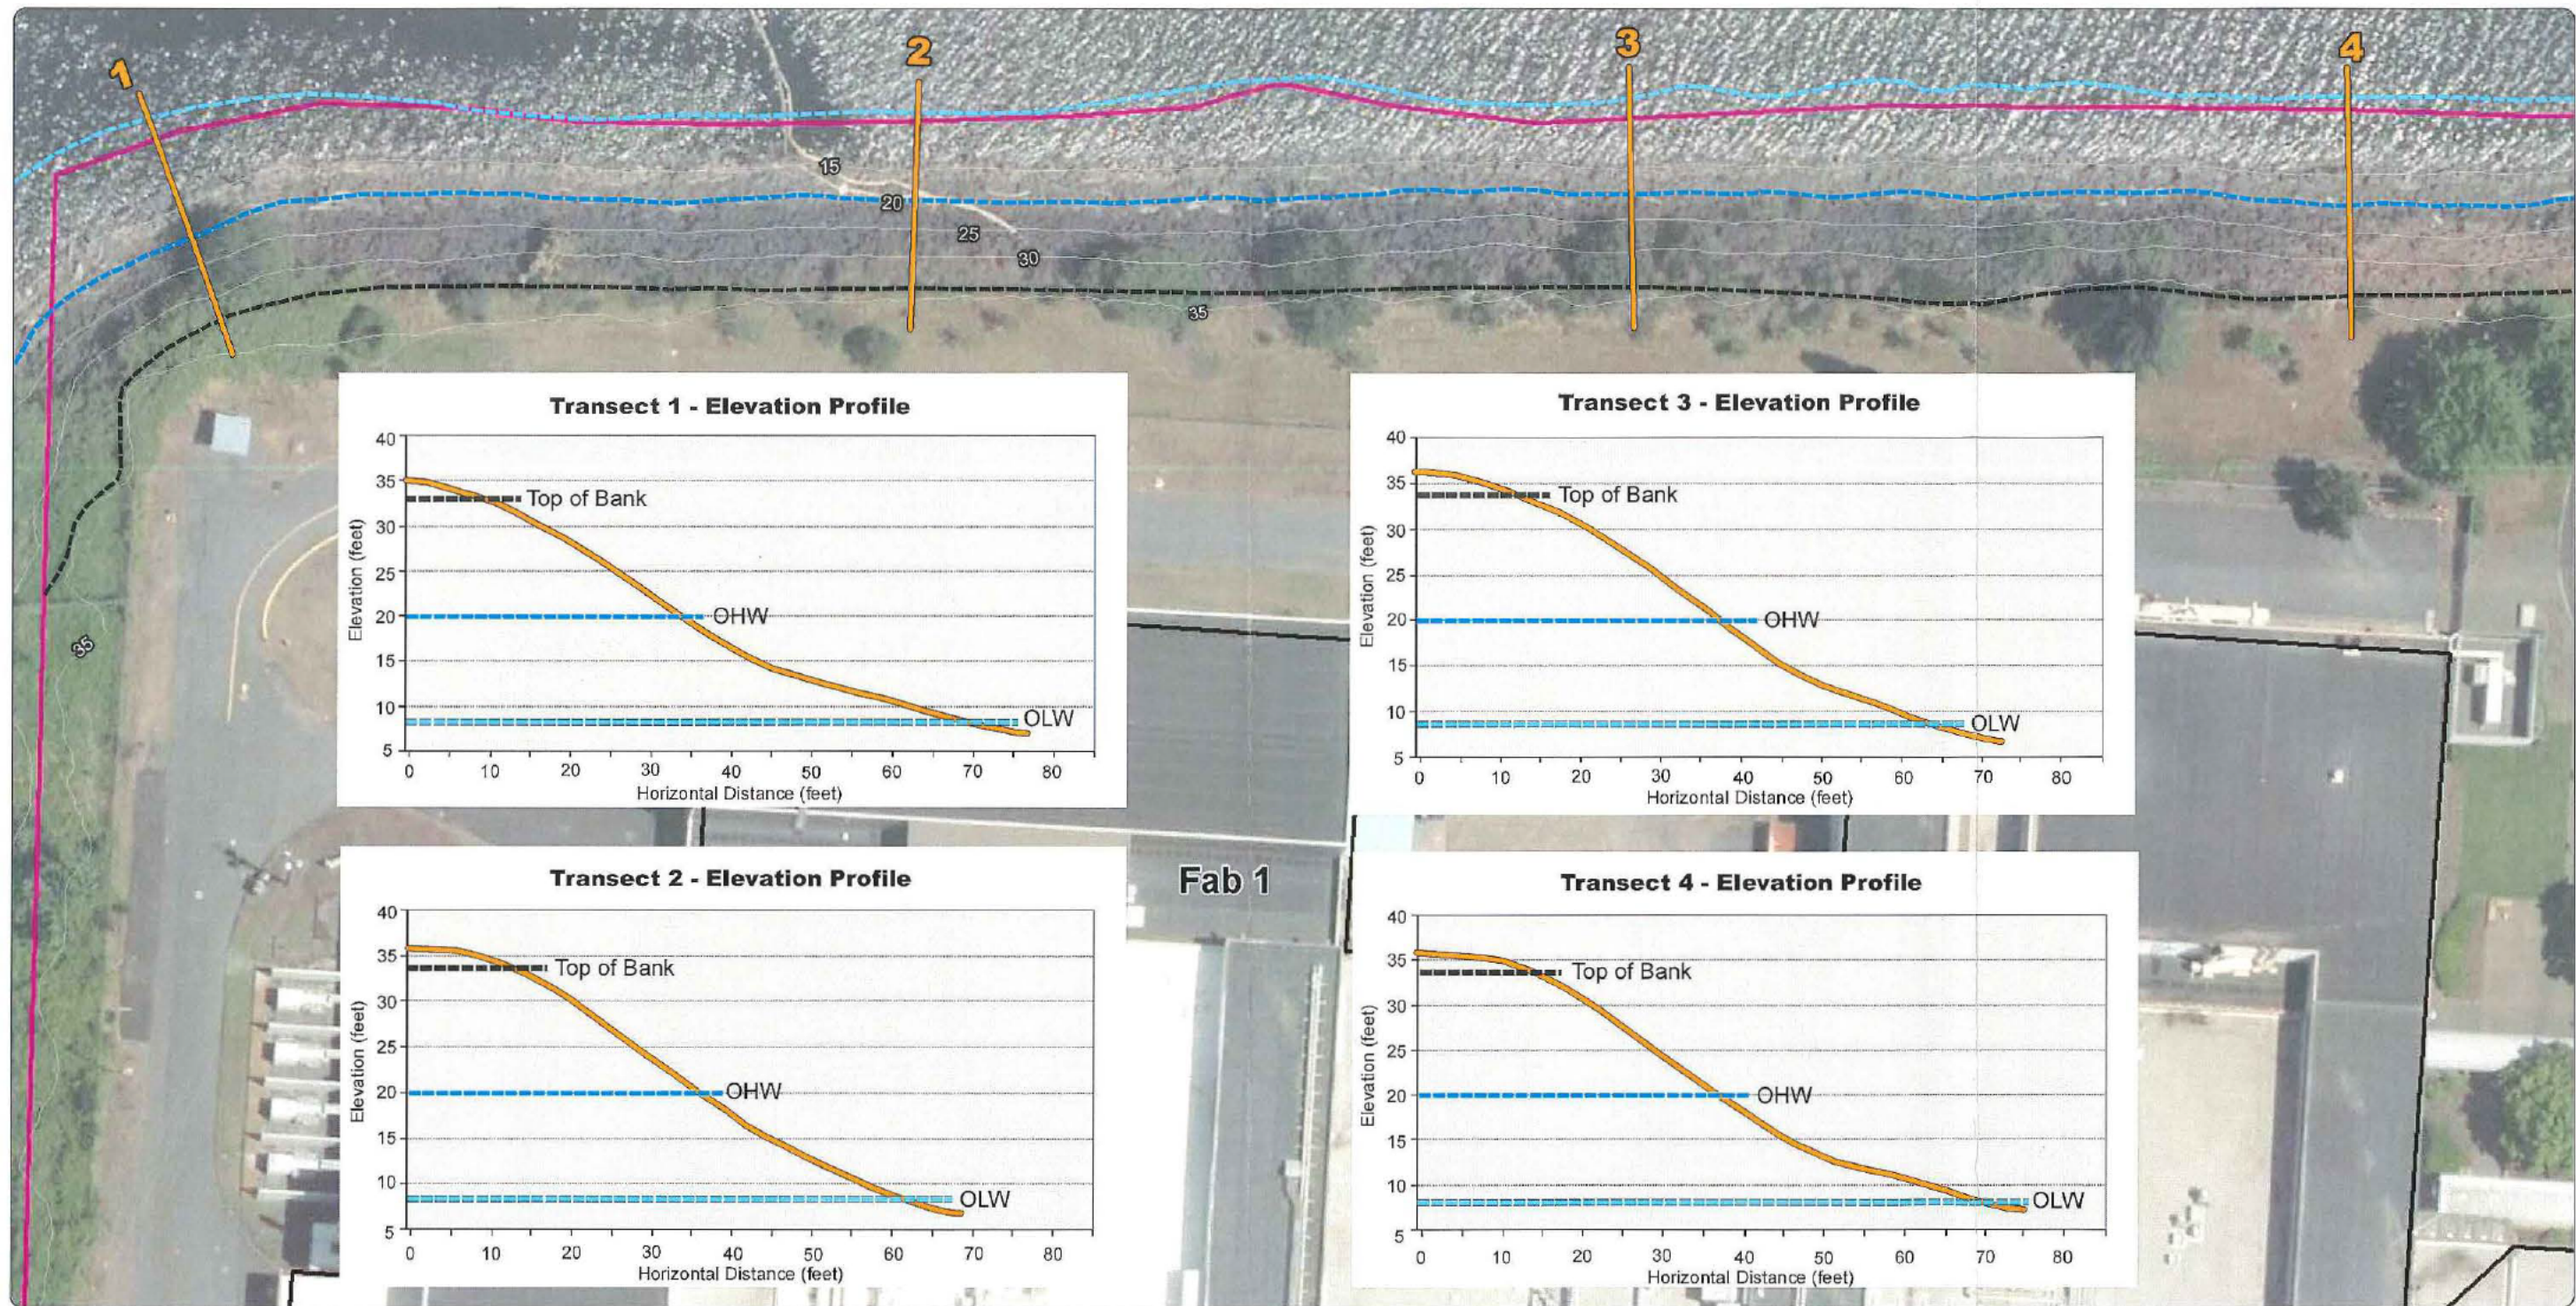
Figure 2
Riverbank Transects 1 - 4
Siltronic Corporation
Portland, Oregon

Source: Aerial photograph (2012) obtained from City of Portland; National Flood Hazard dataset obtained from FEMA; elevations obtained from 2005 Columbia River dataset, Puget Sound LiDAR Consortium; Ordinary High Water and Ordinary Low Water data obtained from Oregon Department of State Lands.

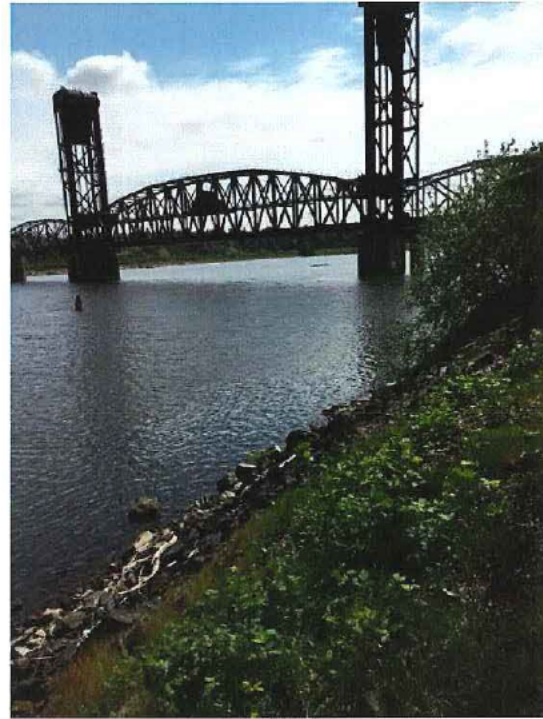
Looking southeast on top
of bank near Transect #9.

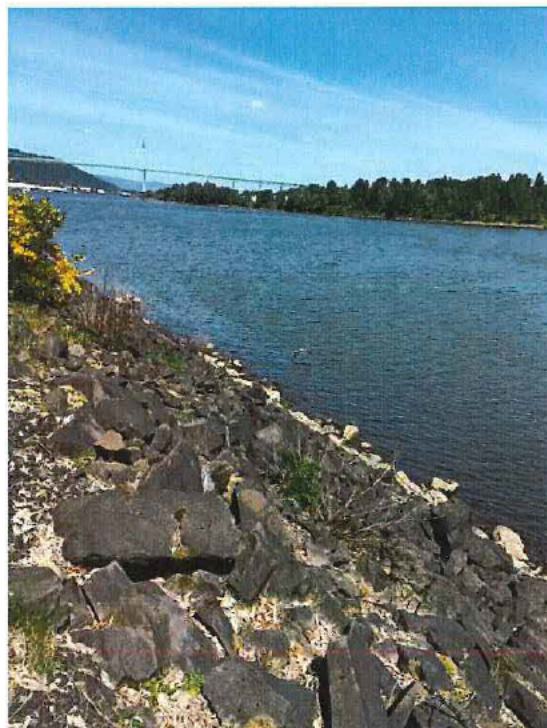
2

Looking northeast on top
of bank near Transect #4.

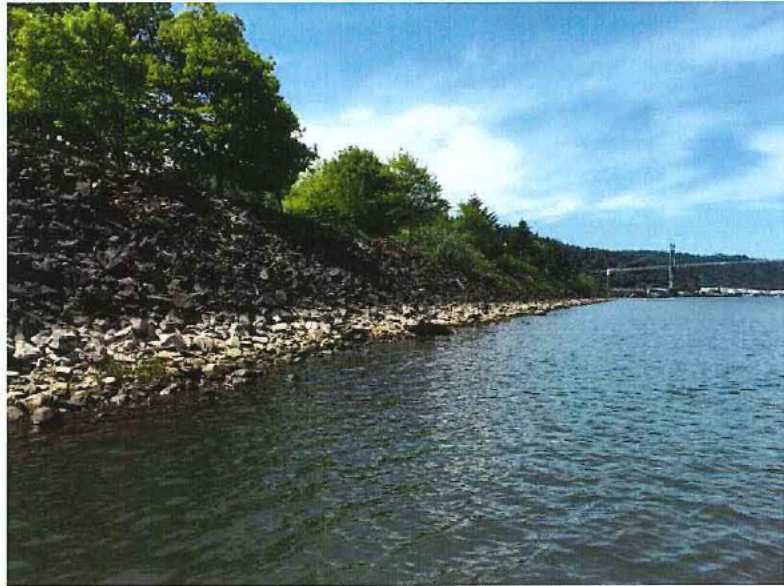
Looking northwest from
water of Transect #10.

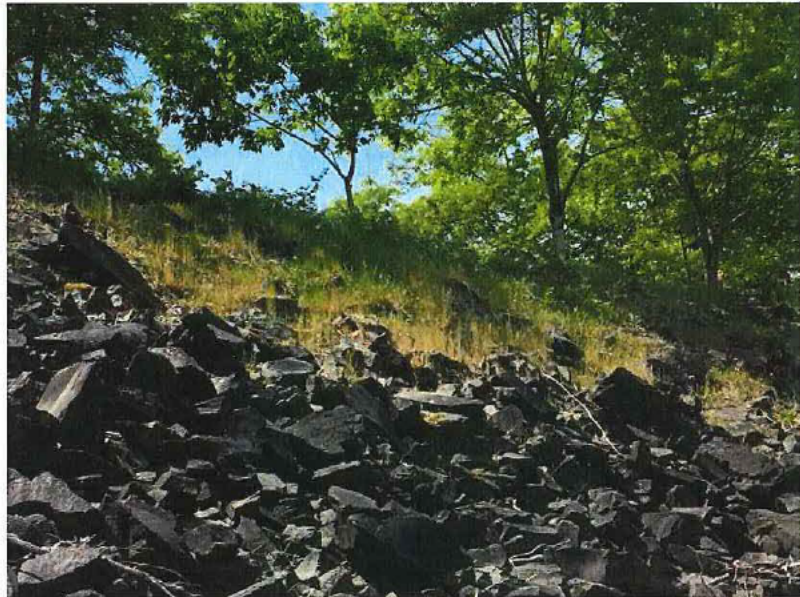
4

Trees on top of bank, looking west
at Transect #10 from water.

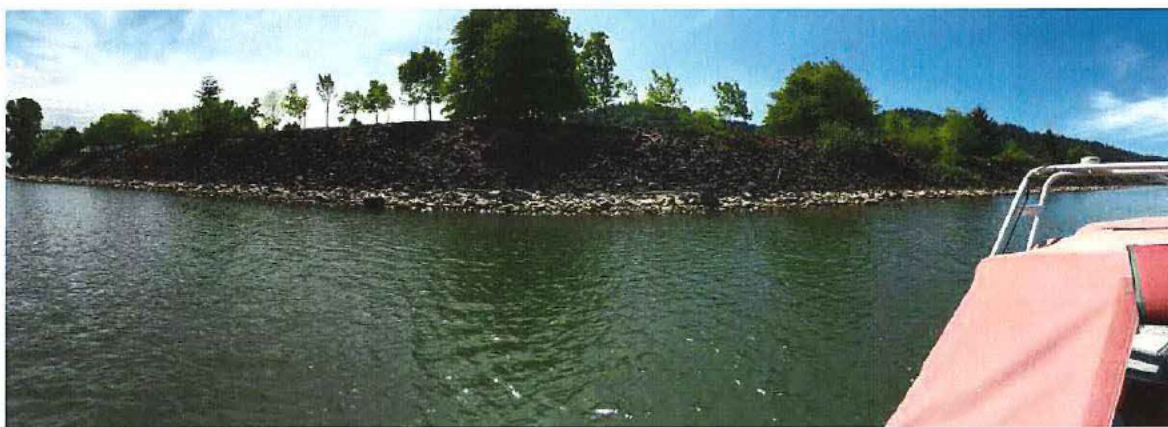
Panoramic view of bank.

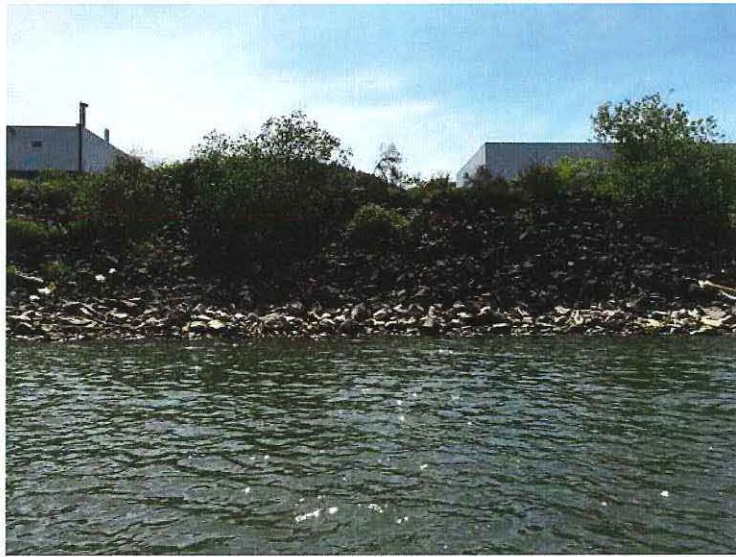
Looking west at Transect #3 from water.

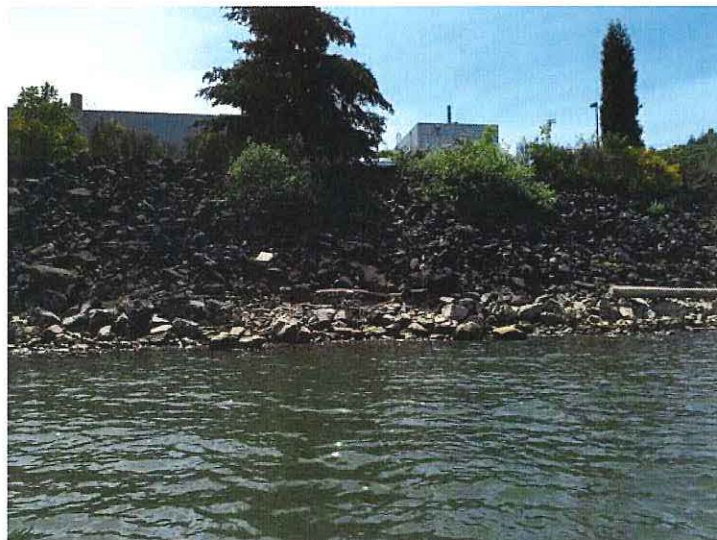
7

Looking west at Transect #5 from water.

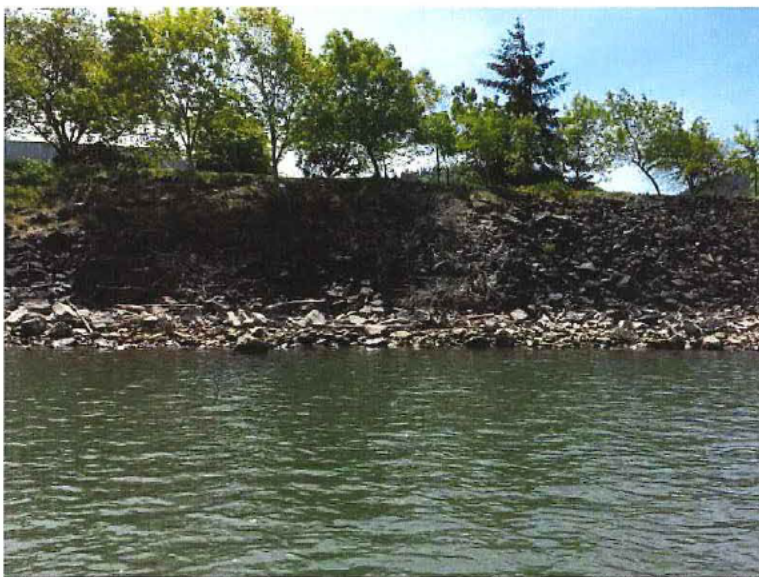
Looking west at Transect #9 from water.

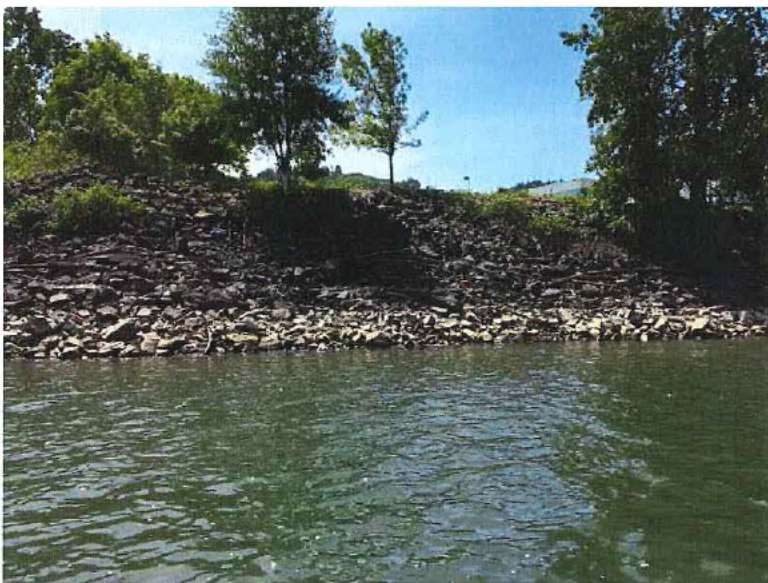
9

Looking west at Transect #11 from water.

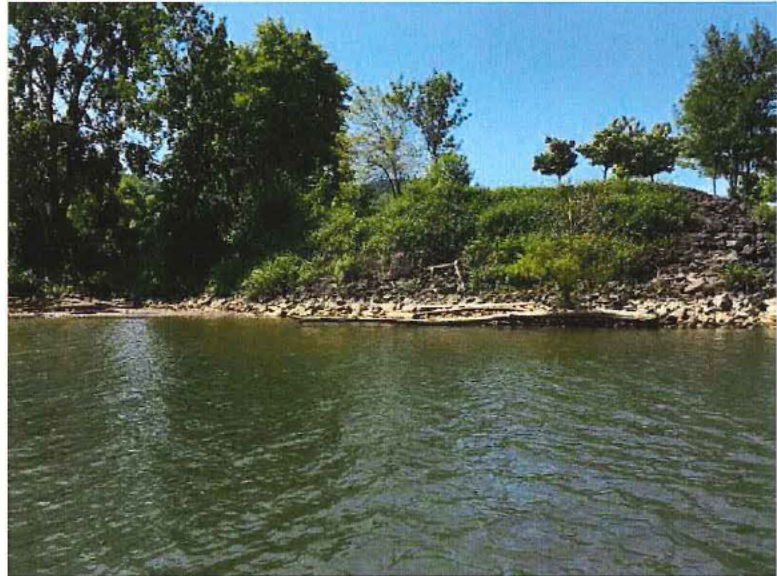
Looking west at Transect #12 from water.

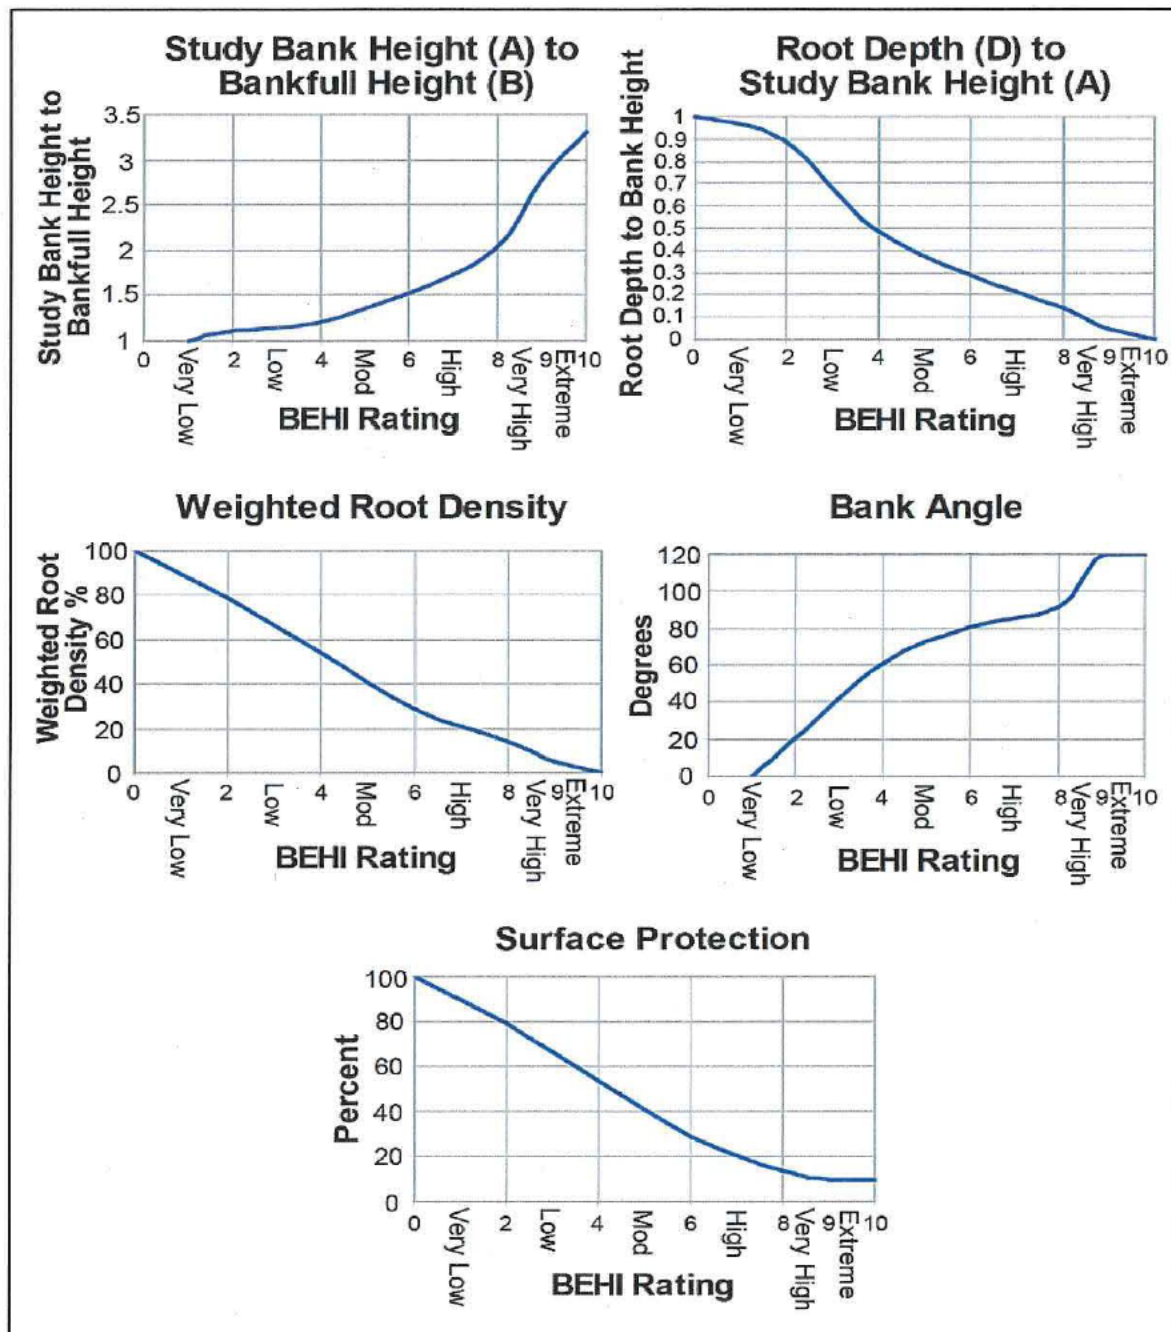
BEHI Rating Scale
(Rosgen, 2014)

Figure 3-7. Streambank erodibility criteria showing conversion of measured ratios and bank variables to a BEHI rating (Rosgen, 1996, 2001b, 2006b). Use **Worksheet 3-11** to determine BEHI score.

Worksheet 3-11. Form to calculate an overall Bank Erosion Hazard Index (BEHI) rating. Use **Figure 3-7** to determine individual BEHI scores.
